## Executive Summary

### The East Branch South Branch Kishwaukee River

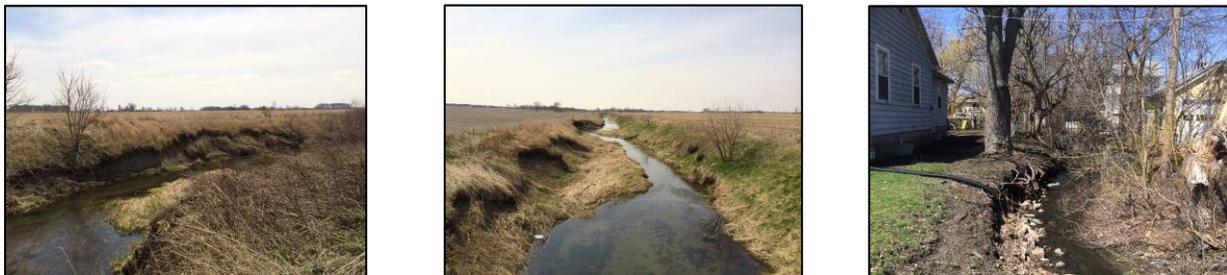
Figure 4 below includes photos of problem areas identified in the watershed. Goals were drafted directly from the concerns expressed by the Watershed Steering Committee members and watershed stakeholders. The final goals were adopted on October 9, 2013 meeting and capture the desired outcomes and vision for East Branch South Branch Kishwaukee River (including Union Ditch and Virgil Ditch) watershed. Objectives assigned to each goal are intended to be measurable so that the DCWSC can assess future progress made towards each goal. The goals are not listed by order of importance.

Figure 4: Photos of Watershed Concerns

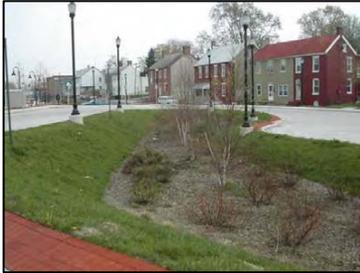
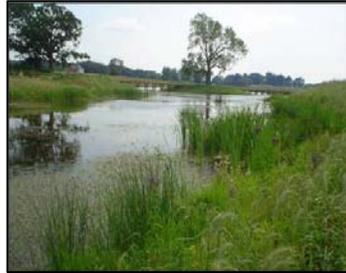
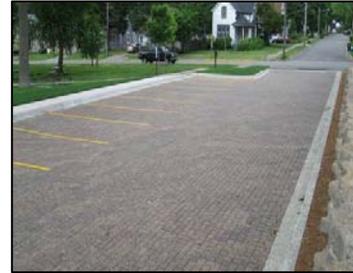
Figure 5: Examples of BMPs that could be implemented in the watershed

- Stabilizing and restoring streambanks using bioengineering techniques.
- Installing rain gardens and bioinfiltration practices to help slow, infiltrate, cool, and cleanse stormwater runoff before being discharged into stream.
- Constructing new and retrofitting existing detention basins to help reduce volume and rate of stormwater released during storm events into streams.
- Reducing the area of impervious surfaces and using permeable pavements that allow water to infiltrate into the ground instead of running off as stormwater runoff.
- Restoring and maintaining native riparian buffers along stream and detention basins.
- Creation/restoration of wetlands to help slow, infiltrate, cool, and cleanse stormwater runoff before being discharged into stream
